NIST NCSTAR 1

Federal Building and Fire Safety Investigation
of the World Trade Center Disaster

Final Report on the **Collapse of** **the World Trade Center Towers**

September 2005

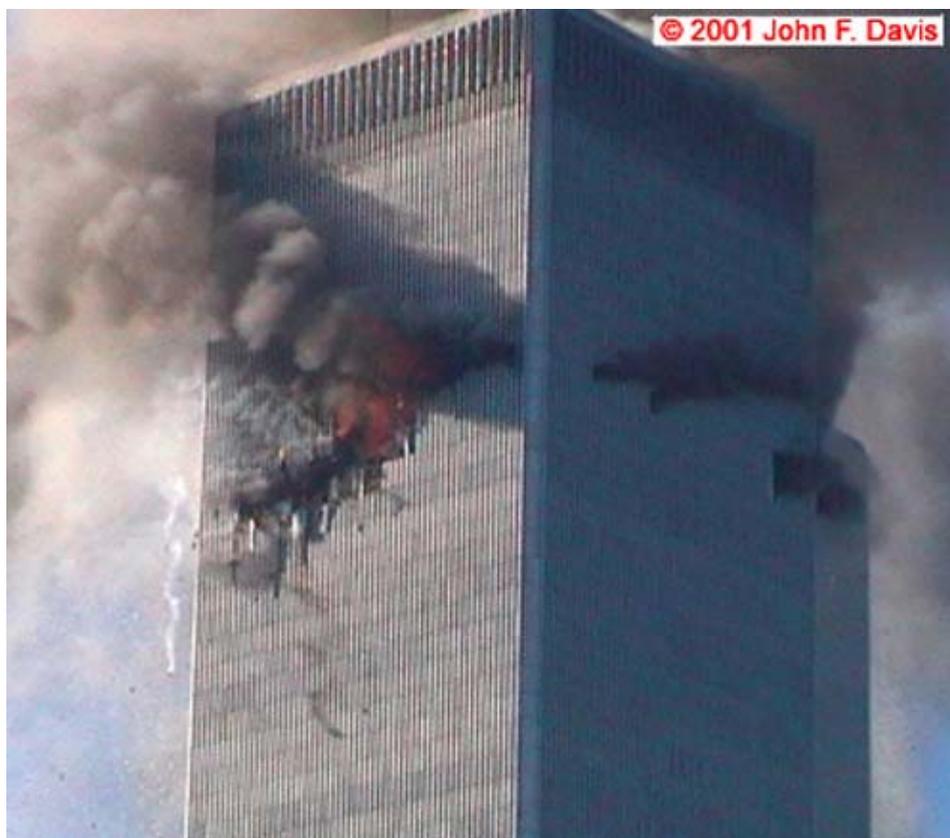
Figure 2–2. Aircraft entry hole on the north side of WTC 1, photographed 30 s after impact.

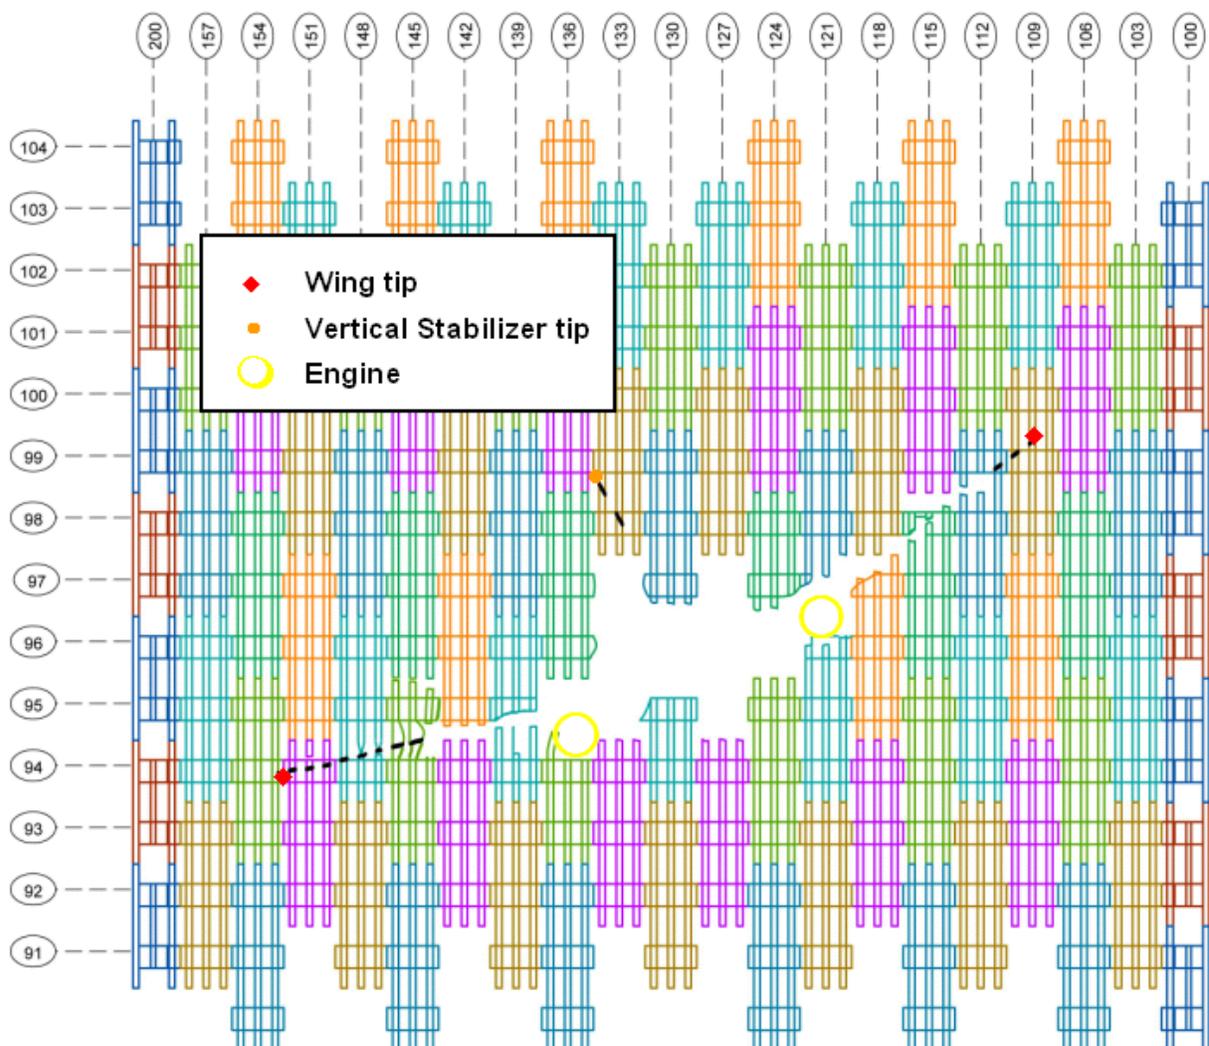
The aircraft did the most damage to the 95th and 96th floors. The fuel-heavy inner left wing hit the 95th floor slab, breaking it over the full 60 ft depth of tenant space and another 20 ft into the building core. The fuselage was centered on the 96th floor slab and filled the 95th and 96th floors top to bottom. The severity of the impact was clear. A wheel from the left wing landing gear flew through multiple partitions, through the core of the building, and became embedded in one of the exterior column panels on the south side of the tower. The impact severed the bolts connecting the panel to its neighbors, and the panel and tire landed on Cedar Street, some 700 ft to the south. A second wheel landed 700 ft further south. Within the two floors, 15 to 18 perimeter columns and five to six core columns were severed, and an additional one to three core columns were heavily damaged. A 40 ft width of the 96th floor slab was broken 80 ft into the building. The insulation was knocked off nearly all the core columns and over a 40 ft width of floor trusses from the south end of the core to the south face of the tower.

Figure 2–3. South face damage of WTC 1 with key aircraft component locations marked.

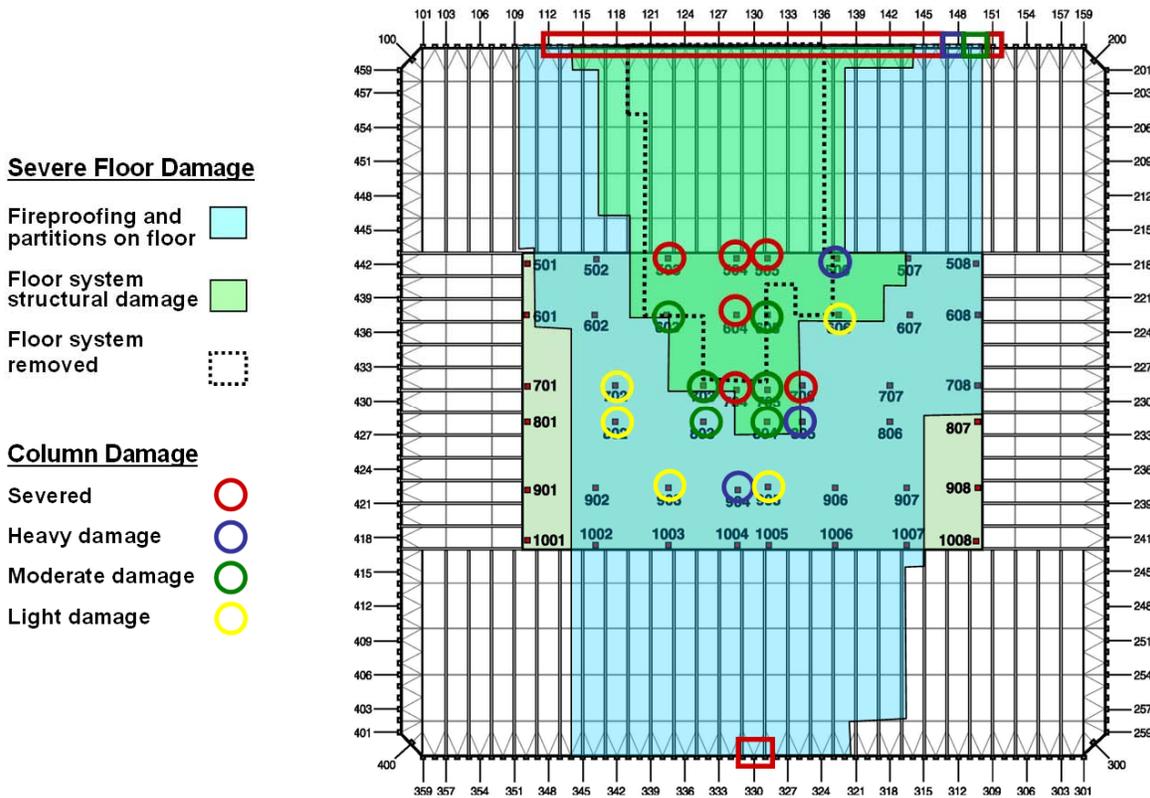
- 43 of 47 core columns stripped of insulation on one or more floors.
- Insulation stripped from trusses covering 60,000 ft² of floor area.

Figure 2-4. Simulation of cumulative aircraft impact damage to floors 93 through 98 in WTC 1.

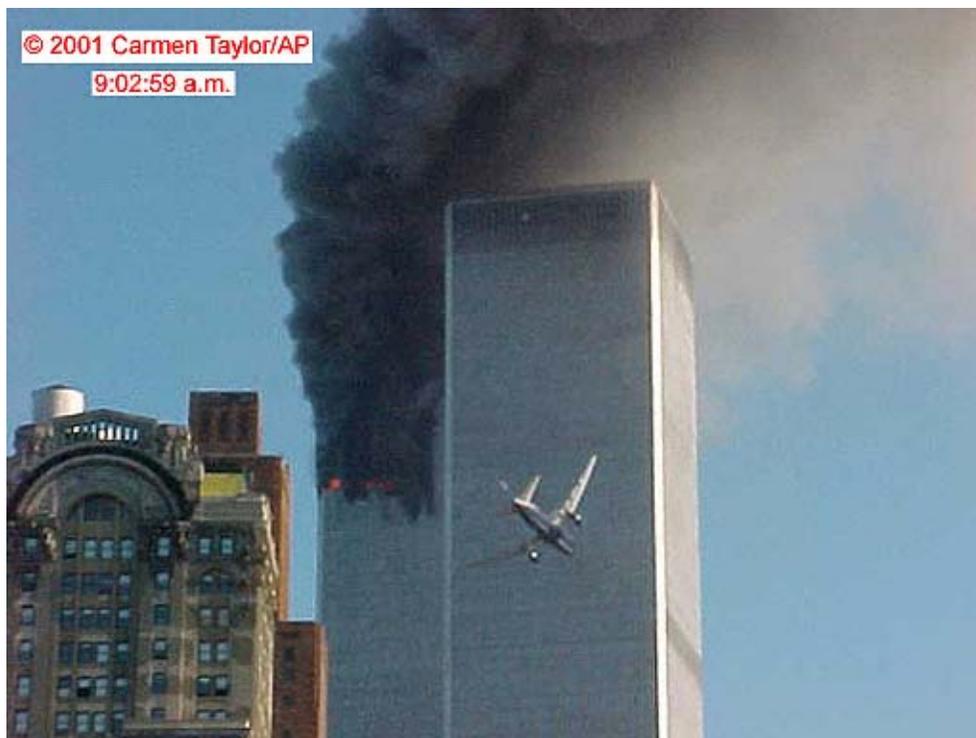
Figure 3–1. Imminent impact of United Airlines Flight 175 with WTC 2.

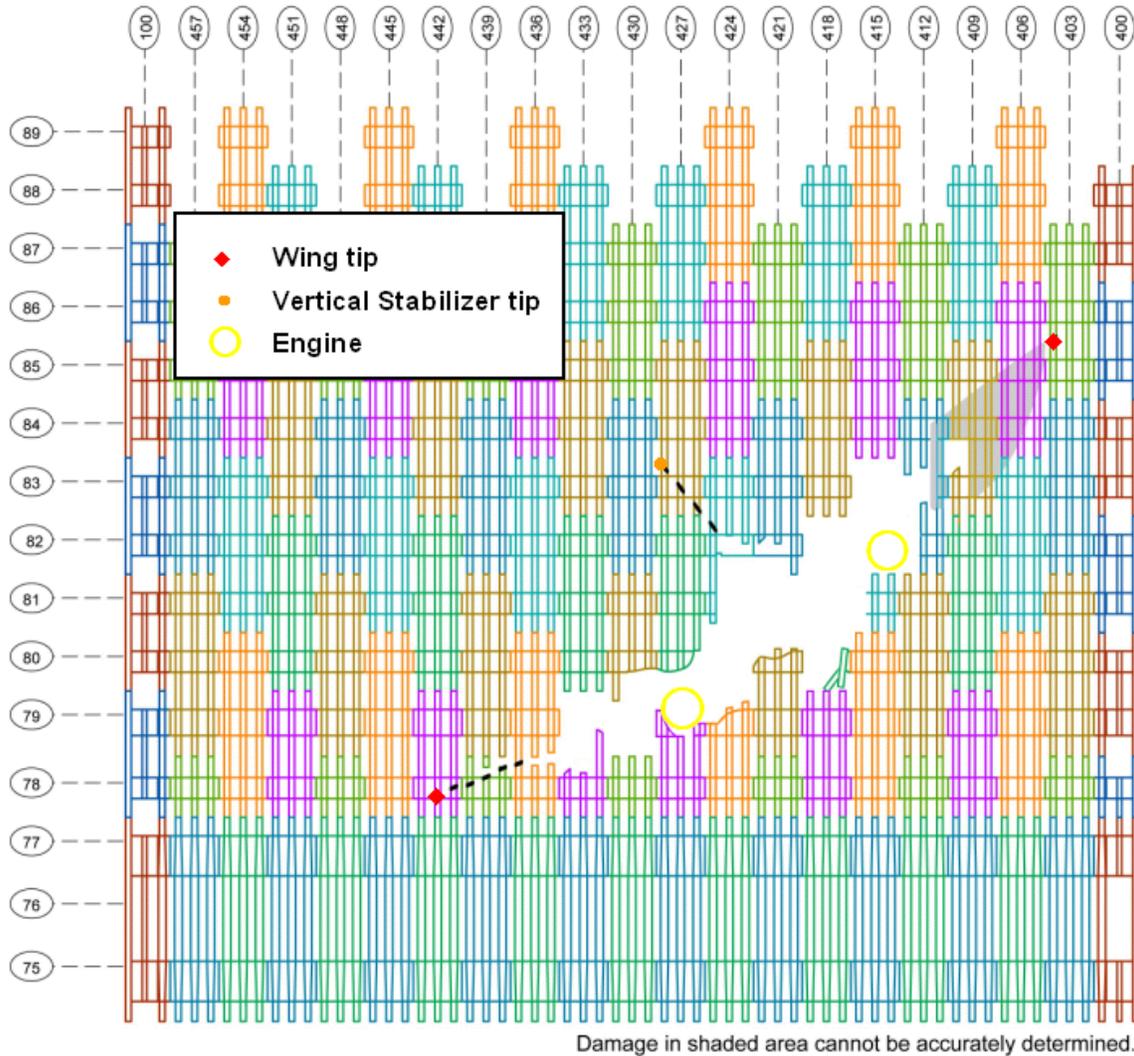
bank angle was steeper than that of AA Flight 11, this entry wound stretched over nine floors, from 77 to 85, rather than eight in WTC 1 (Figure 3–2). The occupancy of those floors is shown in Table 3–1.

Figure 3–2. South face damage of WTC 2 with key aircraft component locations marked.

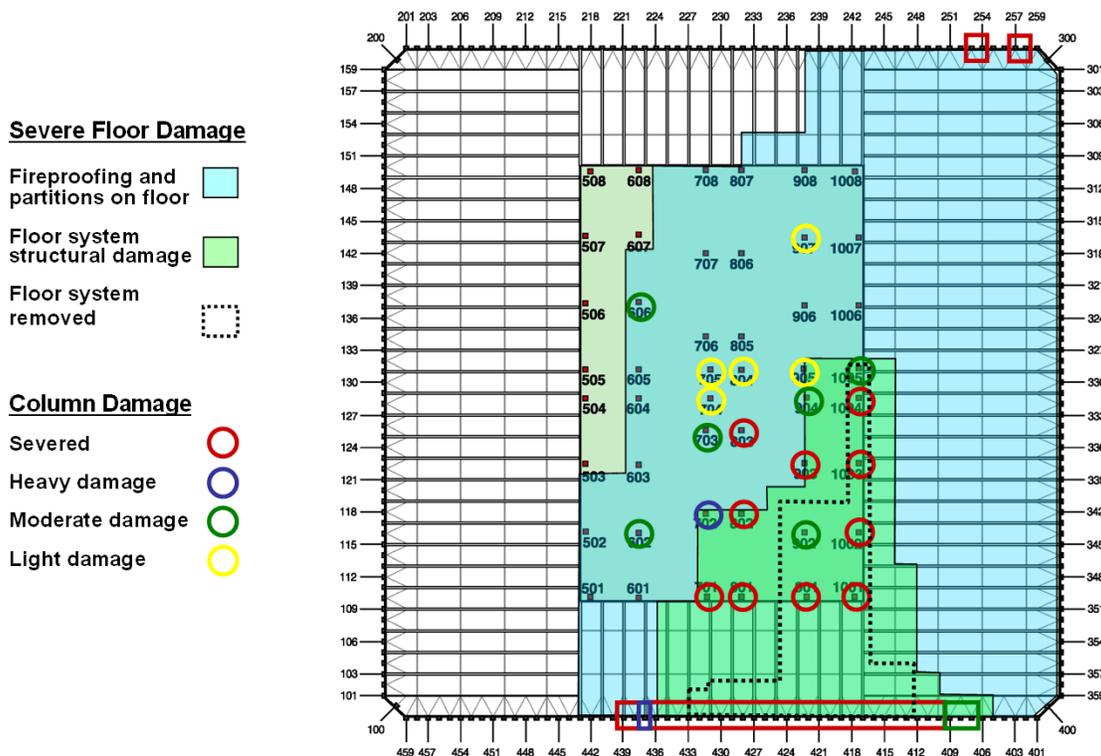
and aluminum sheet of the wing did little damage to the building structure or the SFRM on the columns and trusses on these floors. There were 433 broken windows on the north, east, and south facades.

Figure 3–3. Simulation of aircraft impact damage to the 78th through 83rd floors in WTC 2.

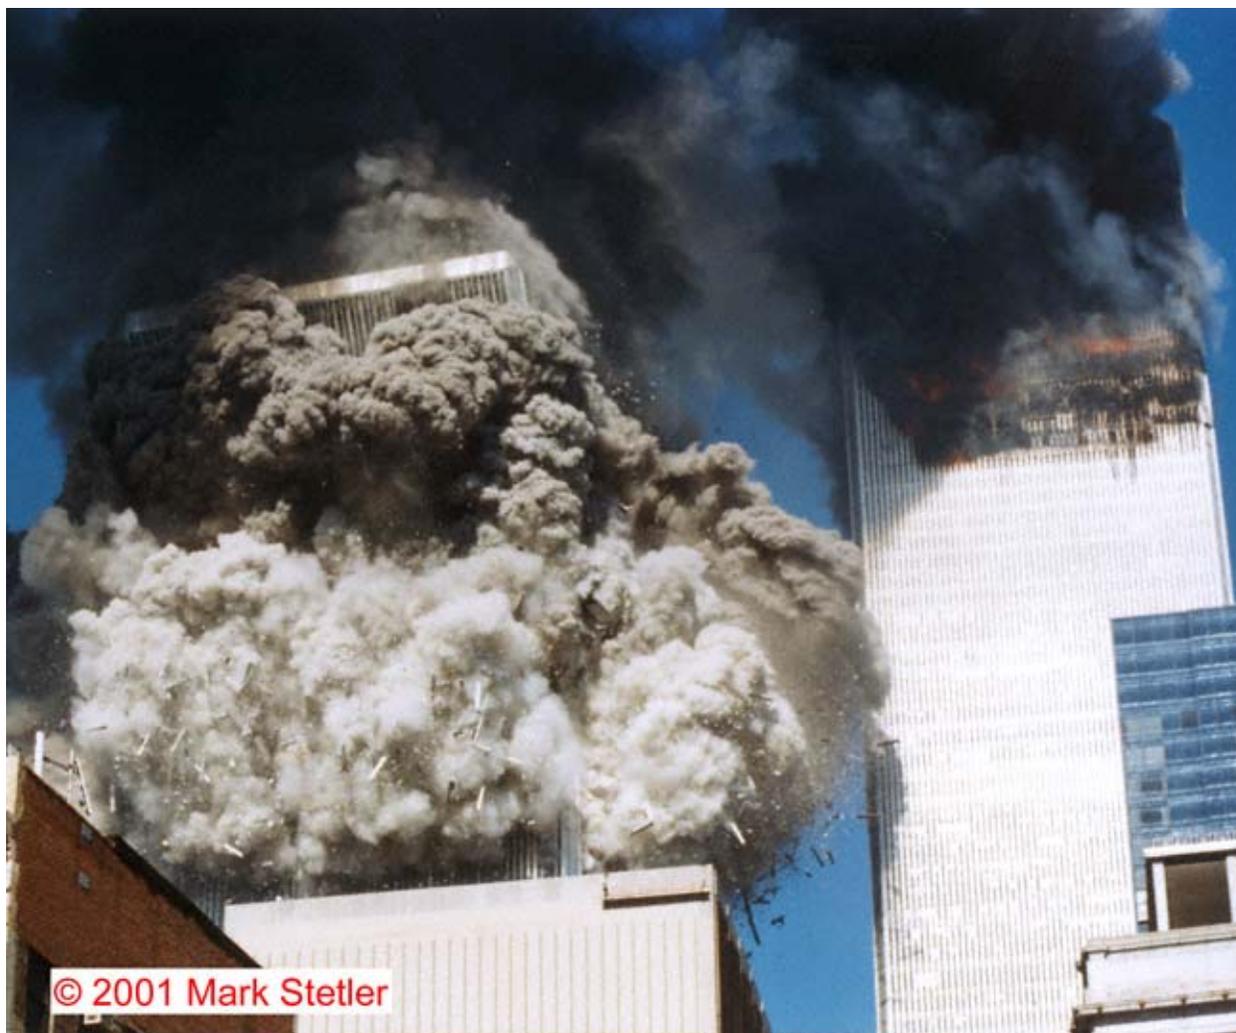
The physical condition of the tower had deteriorated seriously. The inward bowing of columns on the east wall spread along the east face. The east wall lost its ability to support gravity loads, and, consequently, redistributed the loads to the weakened core through the hat truss and to the adjacent north and south walls through the spandrels. But the loads could not be supported by the weakened structure, and the entire section of the building above the impact zone began tilting as a rigid block to the east and south (Figure 3–5). Column failure continued from the east wall around the corners to the north and south faces. The top of the building continued to tilt to the east and south, as, at 9:58:59 a.m., WTC 2 began to collapse.

Figure 3–5. Photograph of WTC 2 tilting to the southeast at the onset of collapse.

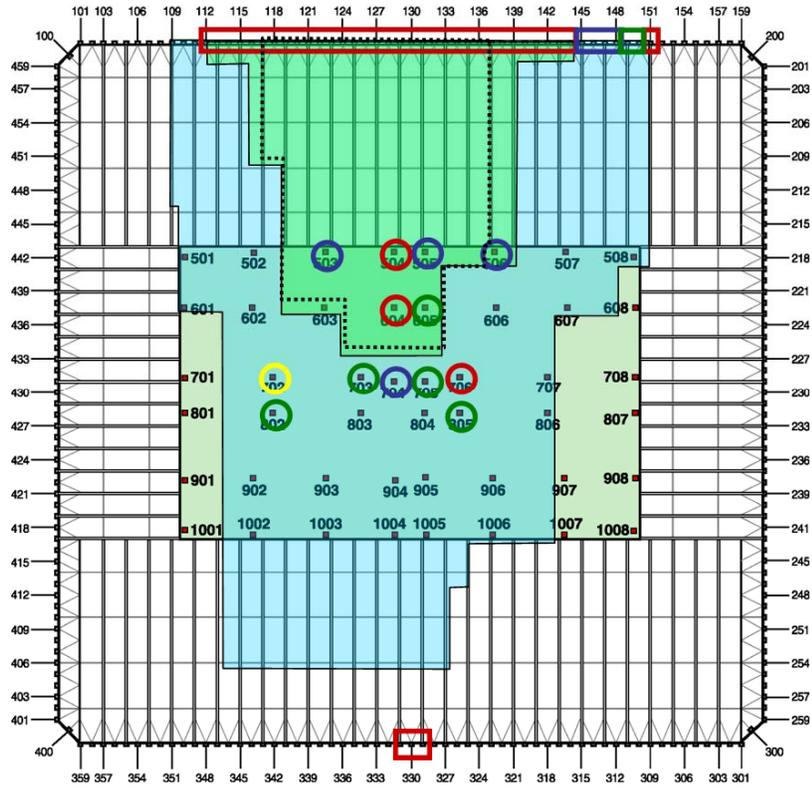
Figure 6–22. Combined structural damage to the floors and columns of WTC 1, Case A.

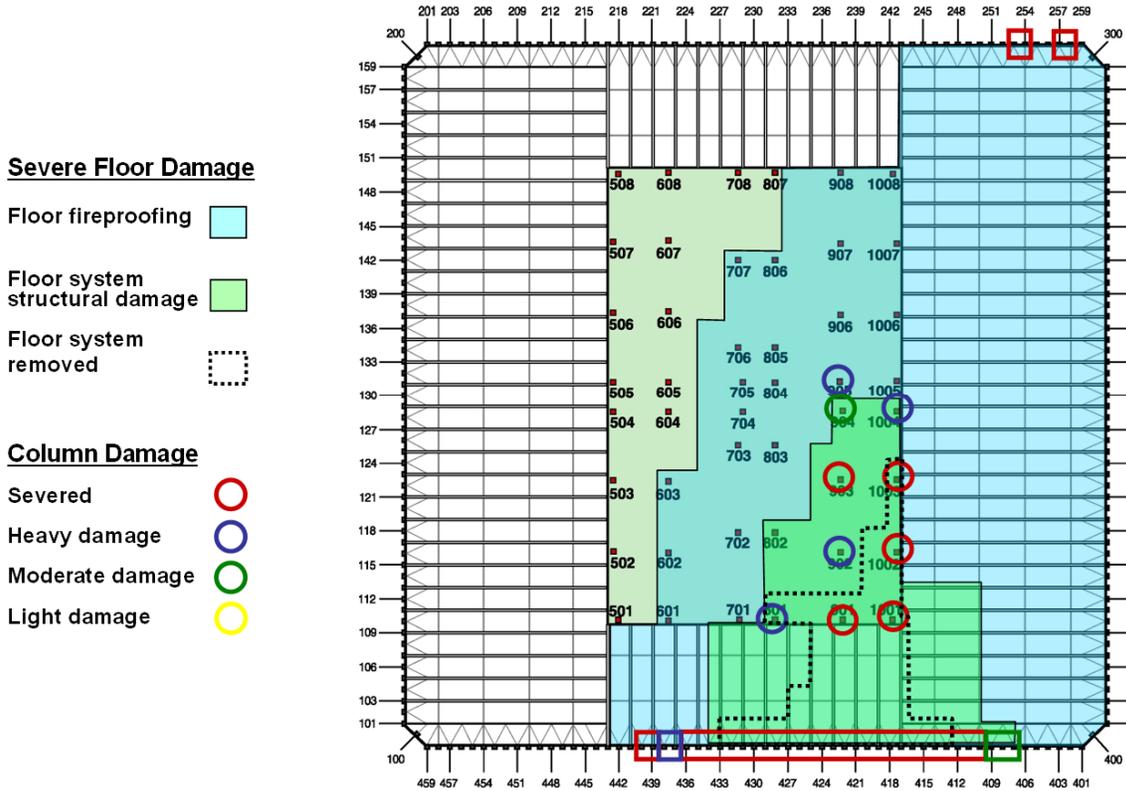
Figure 6-24. Combined structural damage to the floors and columns of WTC 2, Case C.

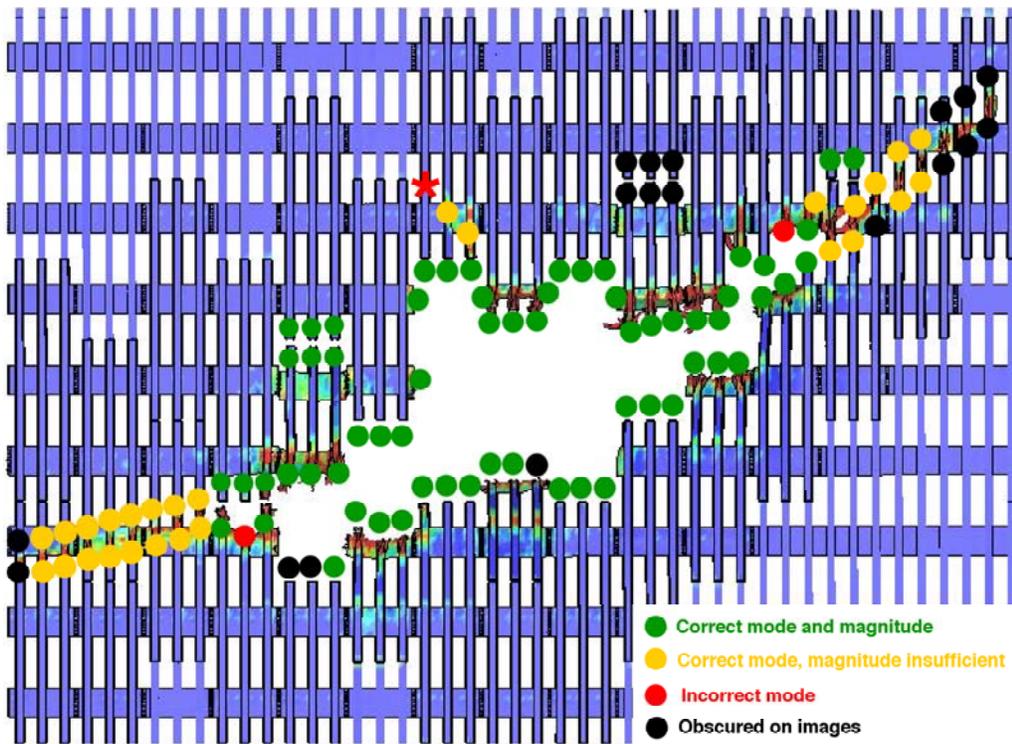
Figure 6–27. Schematic of observed damage (top) and Case A calculated damage (lower) to the north face of WTC 1.

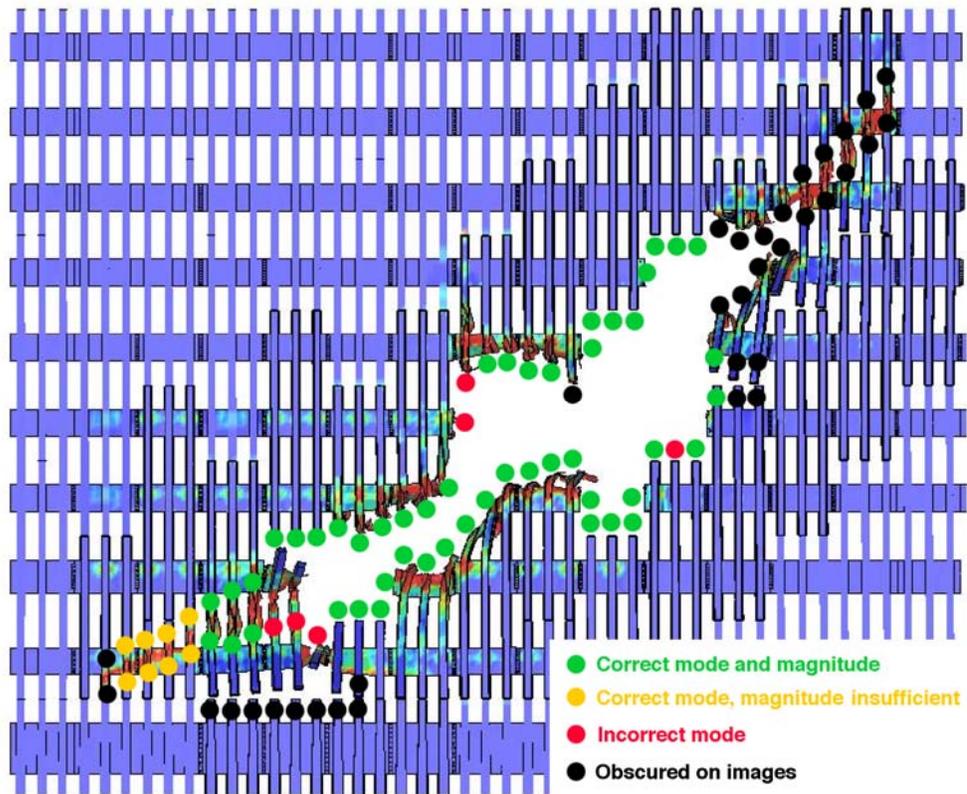
Figure 6–28. Schematic of observed damage (above) and Case C calculated damage (right) to the south face of WTC 2.

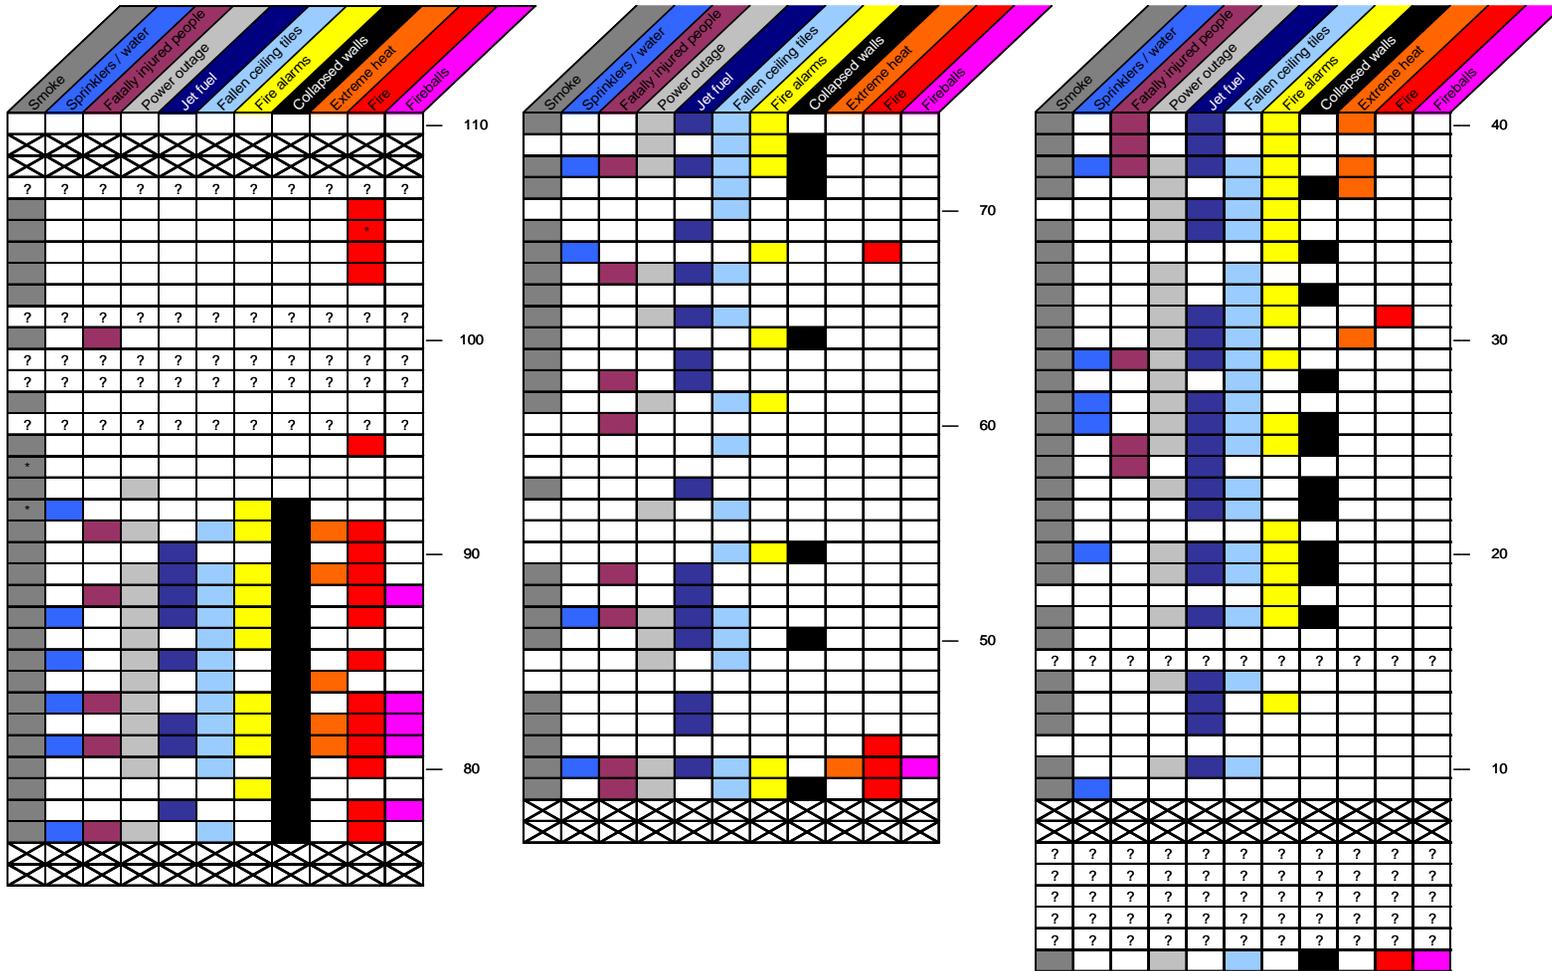
Figure 7-3. Observations of building damage after initial awareness but before beginning evacuation in WTC 1.

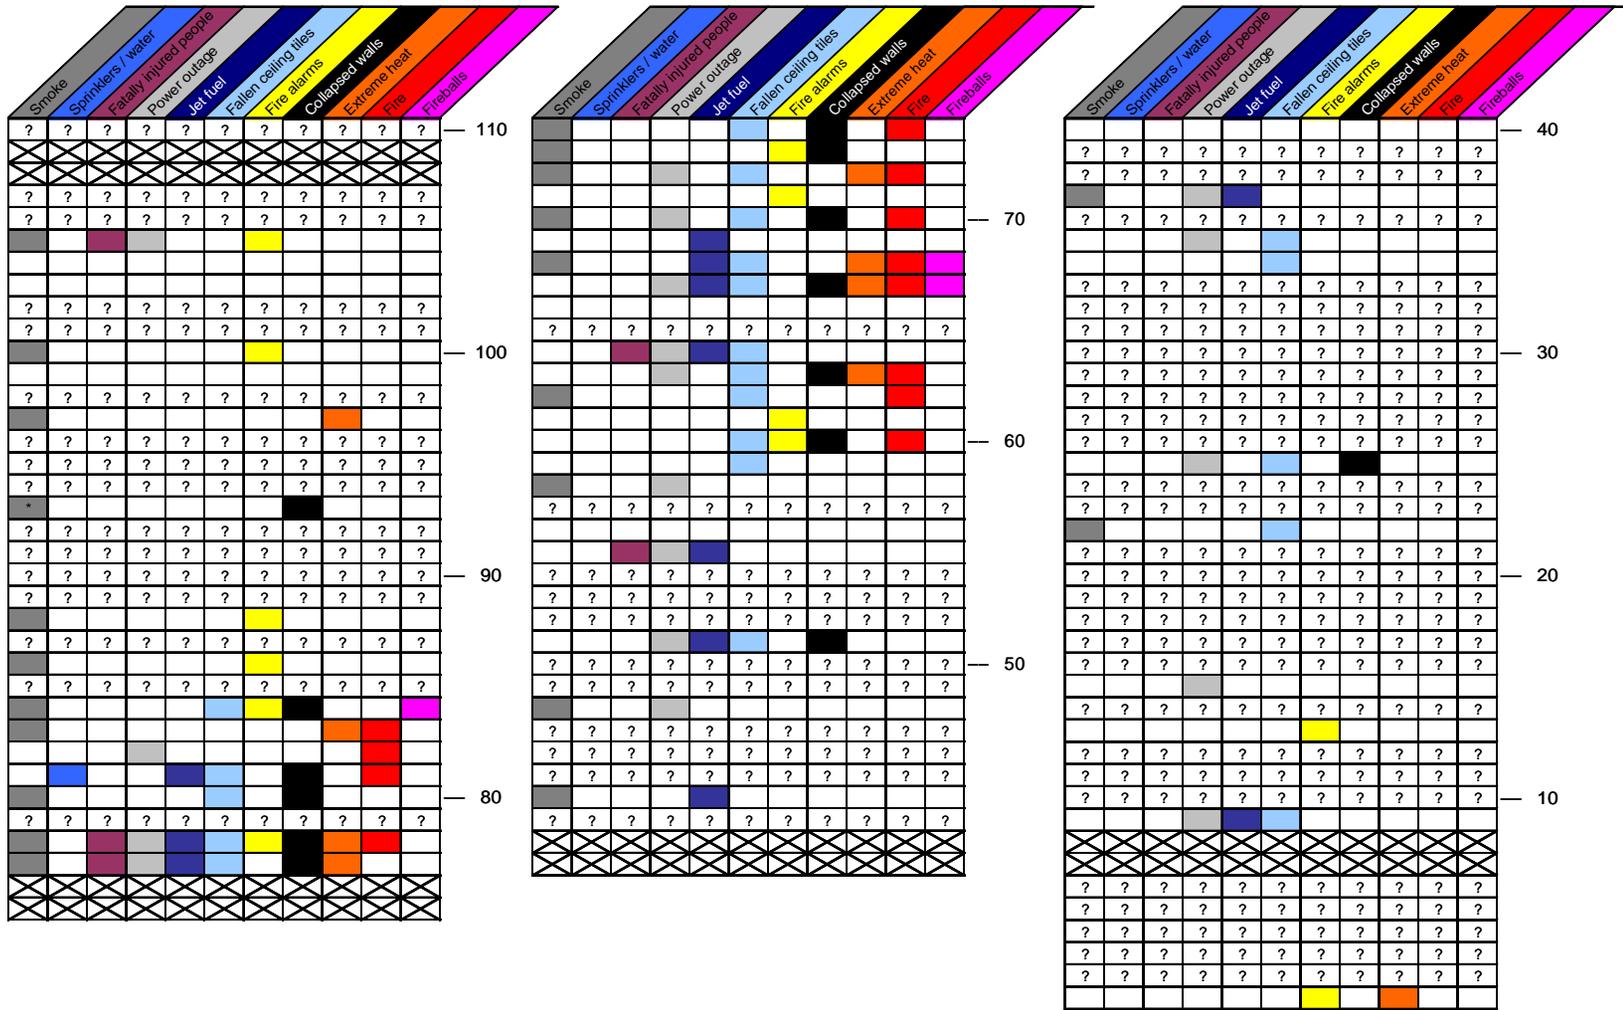
Figure 7-4. Observations of building damage from tenant spaces in WTC 2.
