NIST NCSTAR 1

Federal Building and Fire Safety Investigation
of the World Trade Center Disaster

Final Report on the **Collapse of** **the World Trade Center Towers**

September 2005

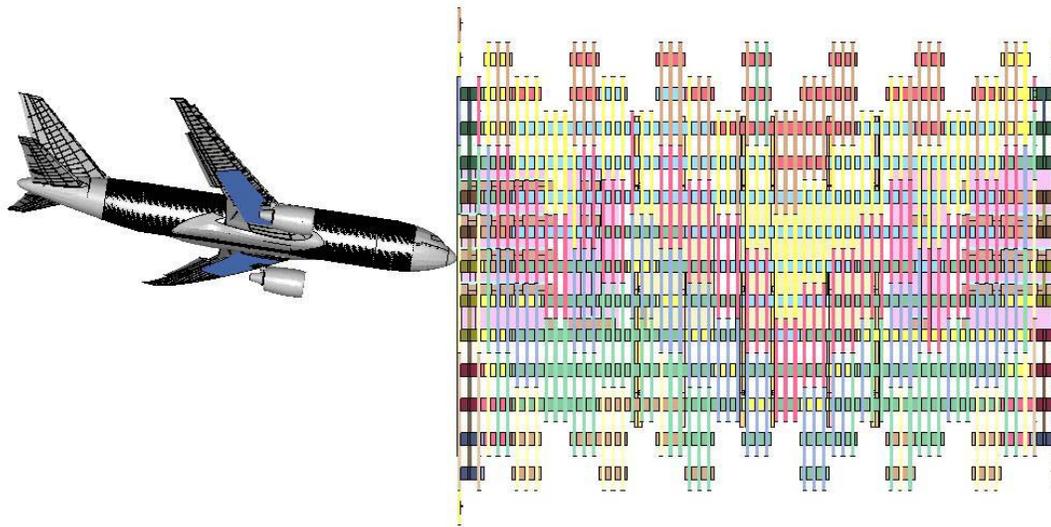
At 8:46:30 a.m. EDT, five hijackers flew American Airlines Flight 11 (AA 11) with 11 crew and 76 passengers into the north face of WTC 1 (Figure 2–1).

Figure 2–1. Simulated impact of American Airlines Flight 11 with WTC 1.

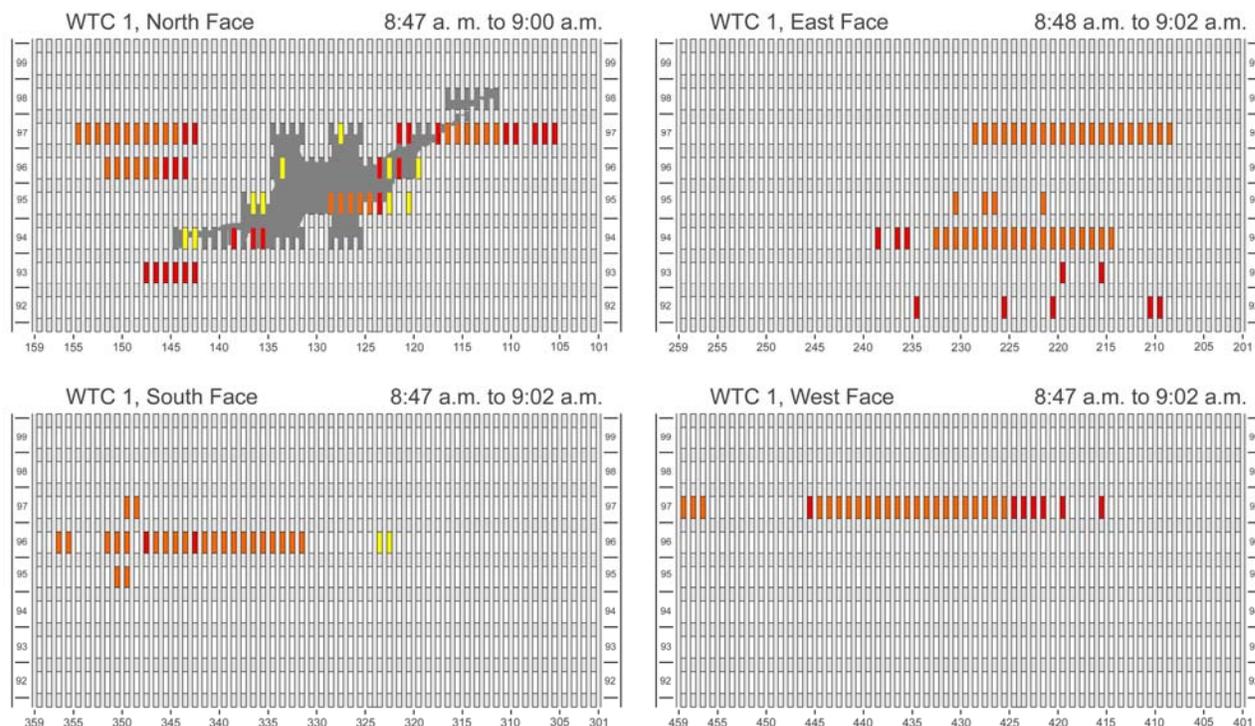
The burning of the jet fuel cloud had consumed much of the oxygen within the 94th and 96th floors, although photographs showing survivors indicated there were some zones with breathable air. The oxygen-starved fires died down, but didn't quite go out. Within the first 2 min after the impact, fires could be seen in the north side windows on the 93rd through 97th floors, the 96th floor of the south face, and the 94th floor of the east face. As fresh air entered the perforated facades, there began the steady burning of the office furnishings and the 13 tons of combustibles from the aircraft that would eventually overwhelm the already damaged building. By 9:00 a.m., these fires had grown and spread to the extent shown in Figure 2-5. In addition to burning around the aircraft entrance hole, there was intense burning on the north, east, and west faces of the 97th floor. Large fires burned on the south side of the 96th floor and the east side of the 94th floor. At 8:52 a.m., a stream of smoke emerged from the south side of the 104th floor, although there was no evidence of a significant fire there yet.

Figure 2-5. Representation of exterior views of the fires on the four faces of WTC 1 from 8:47 a.m. to about 9:02 a.m.

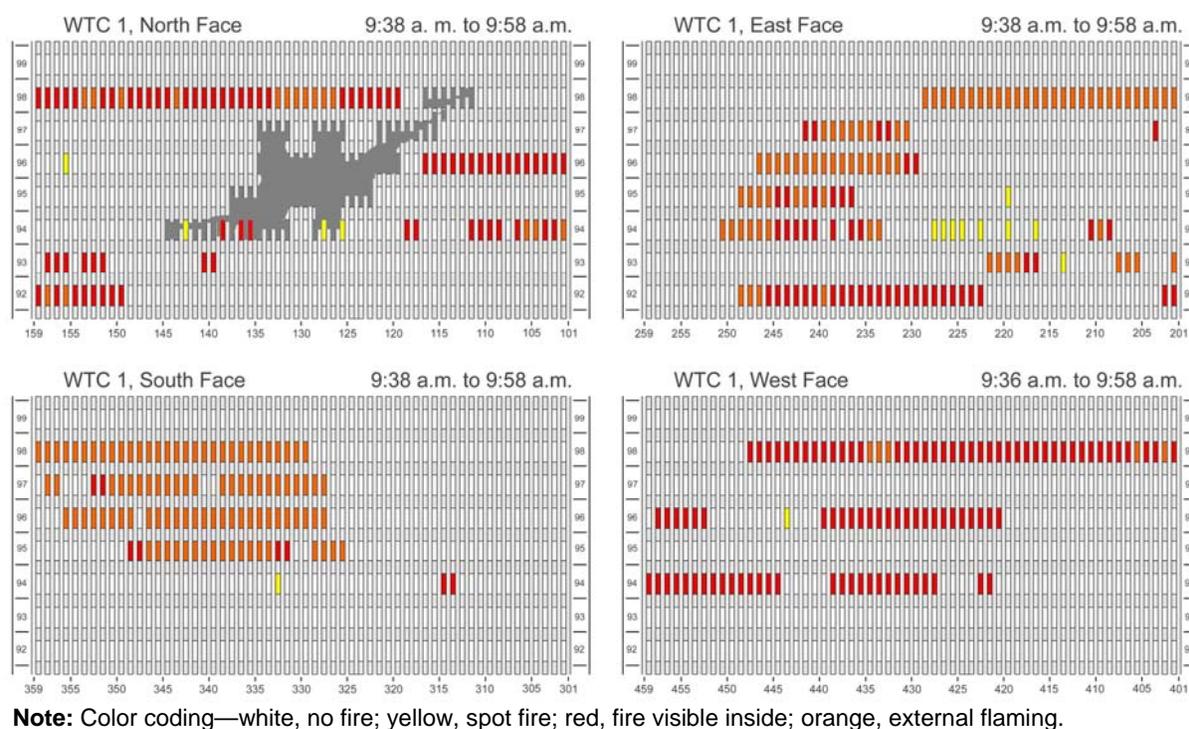
Seventy-five minutes after the impact, approaching 10:00 a.m., the fire on the 97th floor had begun to burn itself out, but the fire on the 94th floor had intensified and filled much of the north half of the floor (Figure 2–7). Starting about 9:30 a.m., there were vigorous fires on nearly the full perimeter of the 98th floor. There was still almost no burning on the 99th floor or above.

Figure 2–7. Representation of exterior views of the fires on the four faces of WTC 1 from about 9:38 a.m. to 9:58 a.m.

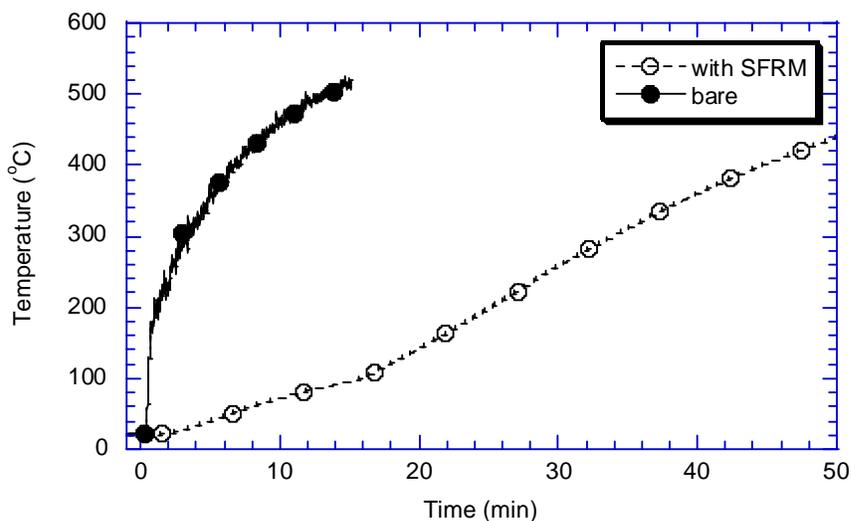
Figure 2–8. Steel surface temperatures on the bottom chords of fire-exposed trusses, uninsulated and insulated with $\frac{3}{4}$ in. of BLAZE-SHIELD DC/F.

The perimeter columns, floors, and core columns were immersed in these hot gases and began to weaken. Where the insulation was dislodged, the temperature of the steel rose rapidly, in contrast to steel members where insulation was intact (Figure 2–8). The heaviest core columns with damaged insulation heated slowly, as the absorbed heat was dissipated through their massive cross sections. The temperatures of the lighter columns and the floor slabs rose more quickly, and those of the stripped trusses even more so.

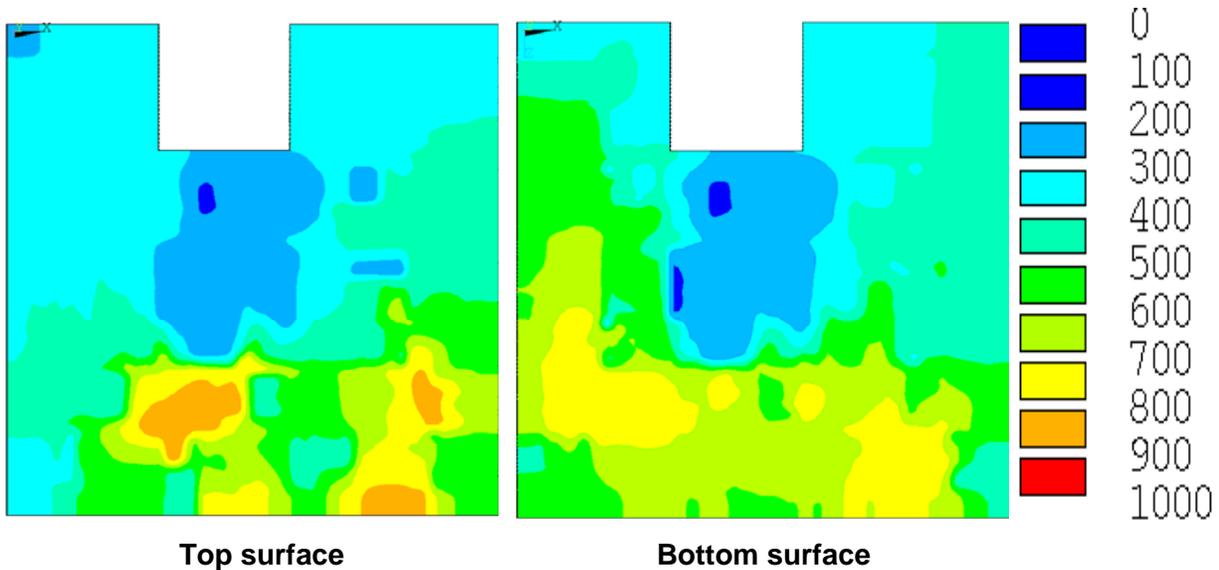
Figure 2–11. Temperature contours (°C) on the top and bottom faces of the concrete slab (96th floor, WTC 1) at 100 min after impact. A portion of the concrete slab on the north face (top) was damaged by the impact of the aircraft.

Simultaneously, the fires were creating another problem for the tower. The floors of the 93rd through the 97th stories were being heated both by the hot gases from below and by thermal radiation from the fires on the floor above (Figure 2–11). On the south side of the building, where the fires were heating the long-span trusses whose SFRM had been dislodged, the floors began to sag. In so doing, they began pulling inward on their connections to the south face and to the core columns. Pull-in forces due to the sagging floors did not fail the floor connections in most areas.

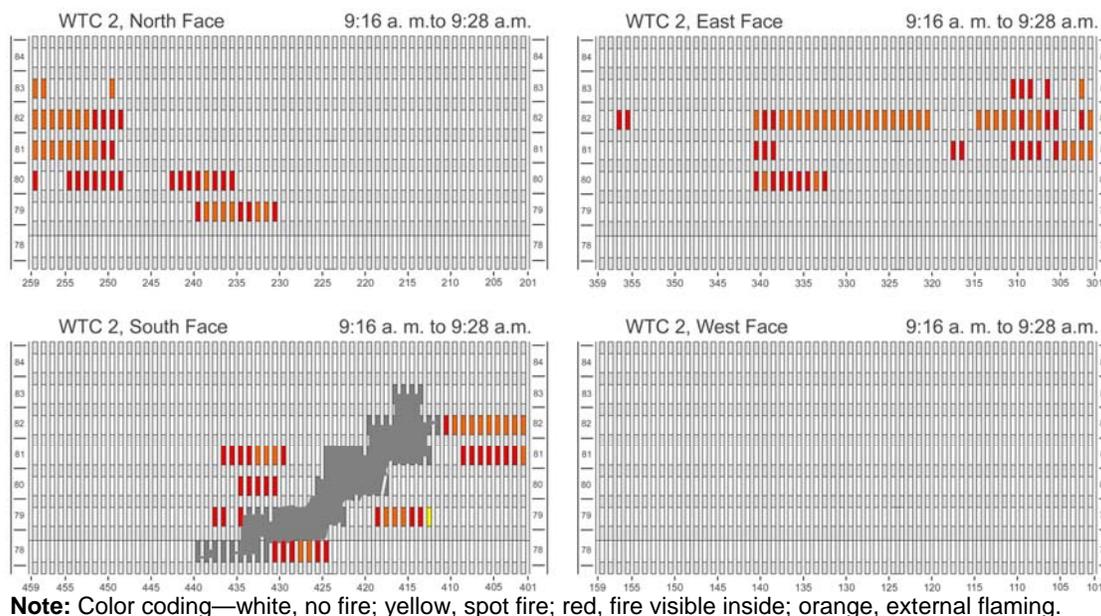
Figure 3–4. Representation of exterior views of the fires on the four faces of WTC 2 at about 9:20 a.m.

For the next half hour, small fires were burning in and near the aircraft impact cavity on the south side of the building. There were vigorous fires on the east side of the 80th through 83rd floors (Figure 3–4), especially on the northeast end of the 81st and 82nd floors, where the aircraft had bulldozed the office desks and chairs and added its own combustibles. In addition to the ample supply of fuel, these fires had access to plenty of air, as numerous windows on the east face had been blown out by the impact or fireball. They would continue to burn as long as the building stood.

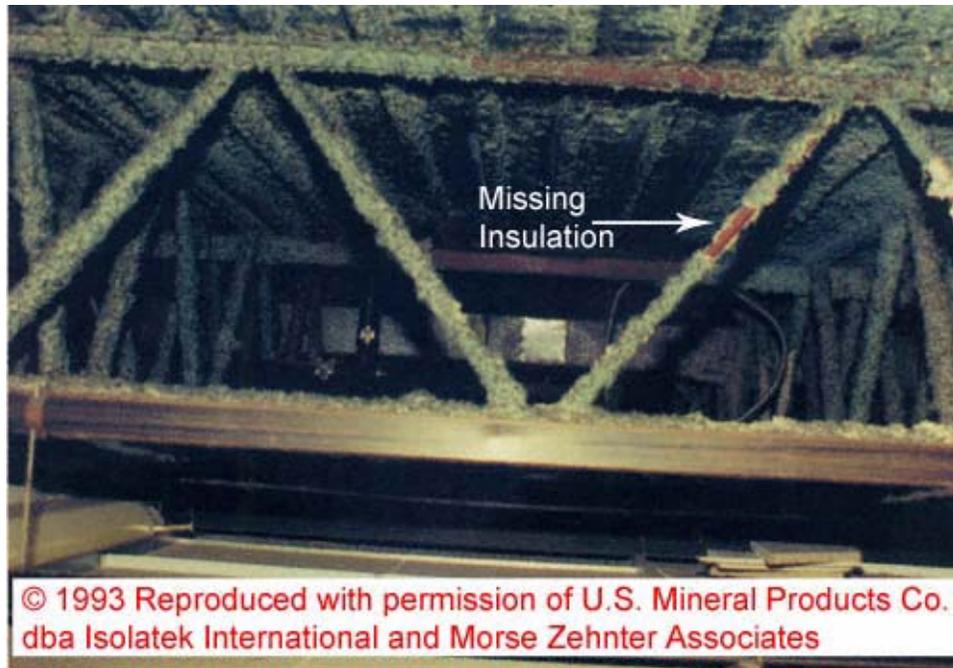
Figure 5–5. Irregularity of coating thickness and gaps in coverage on SFRM-coated bridging trusses.

In 1994, The Port Authority measured the SFRM thickness on trusses on floors 23 and 24 of WTC 1. In all, average thicknesses were reported for 32 locations, and the overall average thickness was found to be 0.74 in. NIST performed a further evaluation of the SFRM thickness using photographs taken in the 1990s of floor trusses on (non-upgraded) floors 22, 23, and 27 of WTC 1 (Figure 5–5). By measuring dimensions on the photographs, NIST estimated the insulation thicknesses on the diagonal web members of trusses. (The thickness of chord member insulation could not be measured.) The average thickness and standard deviation of web members was 0.6 in. ± 0.3 in. on the main trusses, 0.4 in. ± 0.25 in. on the bridging trusses, and 0.4 in. ± 0.2 in. on the diagonal struts. These numbers indicated that there were areas where the coating thickness was less than the specified 0.5 in.

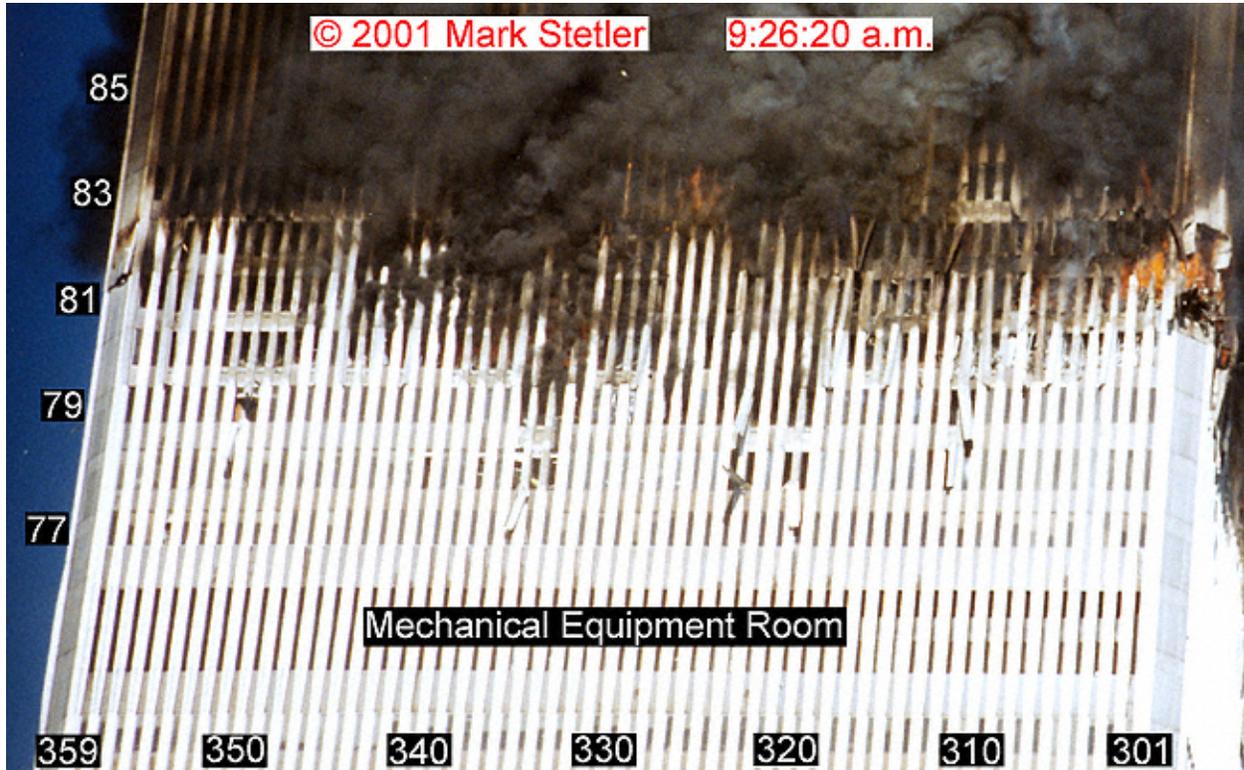
Figure 6–1. 9:26:20 a.m. showing the east face of WTC 2.

As an example of information that was extracted, Figure 6–1 shows an enhanced image of the east face of WTC 2. Figure 6–2 expands a section of interest. The amount of detail available is evident. For instance, large piles of debris are present on the north side of the tower on the 80th and 81st floors, and locations where fires are visible or where missing windows are easily identified. Many details of each frame were important in tracking the evolution of the fires and the damage to the buildings.

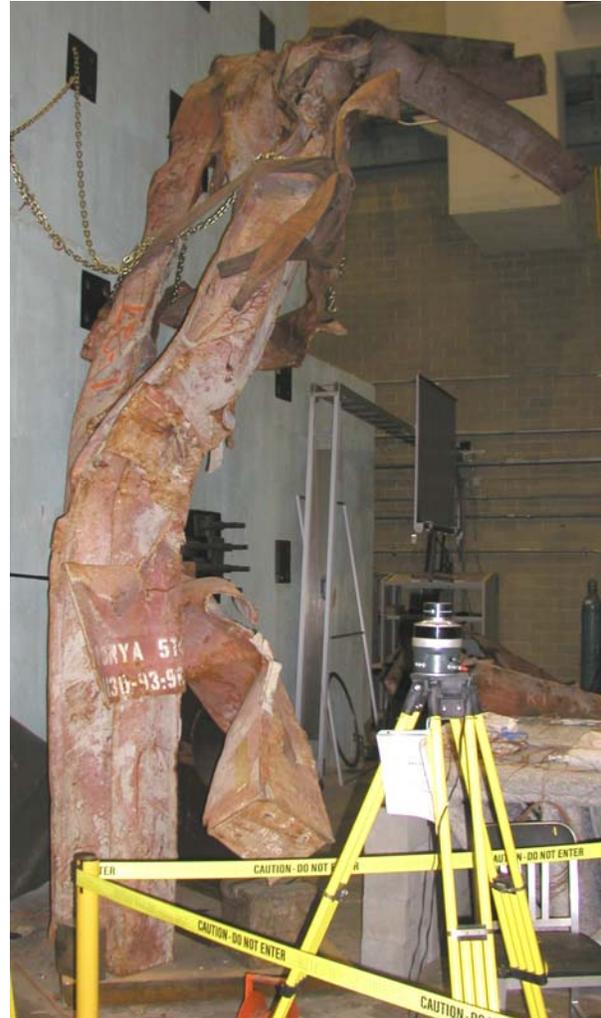
Figure 6–5. WTC 1 exterior panel hit by the nose of the aircraft.

For two of the five exterior panels from the impact zone of WTC 1, the general shape and appearance of the recovered pieces matched photographs taken just before the building collapse. Thus, NIST was able to attribute the observed damage to the aircraft impact. NIST also made determinations regarding the connections between structural steel elements:

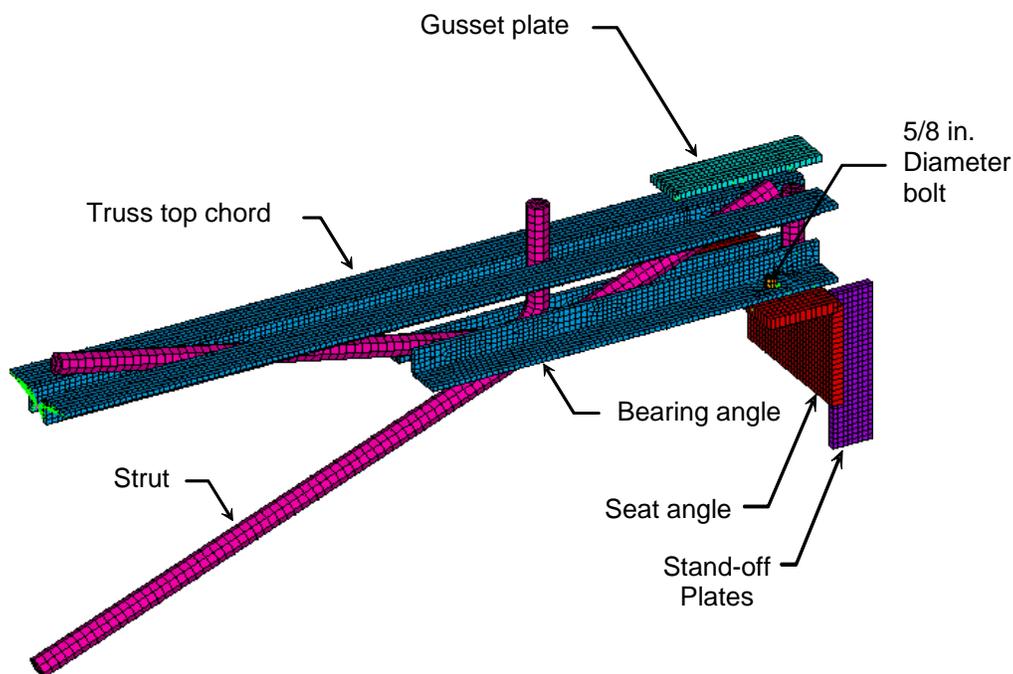
Figure 6–10. Finite element model of an exterior truss seat.

- Truss seats. Figure 6–10 shows how an exterior seat connection was represented in the finite element structural model. The component analysis determined that failure could occur at the bolted connection between the bearing angle and the seat angle, and the truss could slip off the seat. Truss seat connection failure from vertical loads was found to be unlikely, since the needed increase in vertical load was unreasonable for temperatures near 600 °C to 700 °C.
- Knuckles. The “knuckle” was formed by the extension of the truss diagonals into the concrete slab and provided for composite action of the steel truss and concrete slab. A model was developed to predict the knuckle performance when the truss and concrete slab acted compositely.

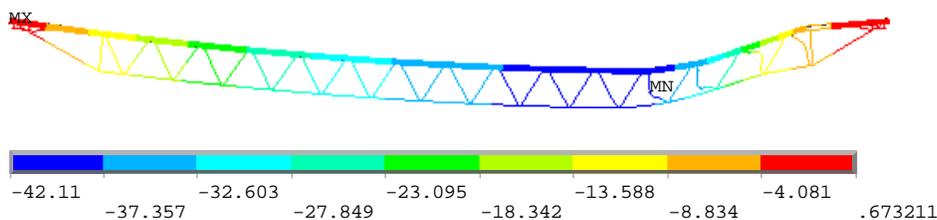
Figure 6–11. Vertical displacement at 700 °C.

- Single composite truss and concrete slab section. A floor section was modeled to investigate failure modes and sequences of failures under combined gravity and thermal loads. The floor section was heated to 700 °C (with a linear thermal gradient through the slab thickness from 700 °C to 300 °C at the top surface of the slab) over a period of 30 min. Initially the thermal expansion of the floor pushed the columns outward, but with increased temperatures, the floor sagged and the columns were pulled inward. Knuckle failure was found to occur mainly at the ends of the trusses and had little effect on the deflection of the floor system. Figure 6–11 shows that the diagonals at the core (right) end of the truss buckled and caused an increase in the floor system deflection, ultimately reaching approximately 42 in. Two possible failure modes were identified for the floor-truss section: sagging of the floor and loss of truss seat support.

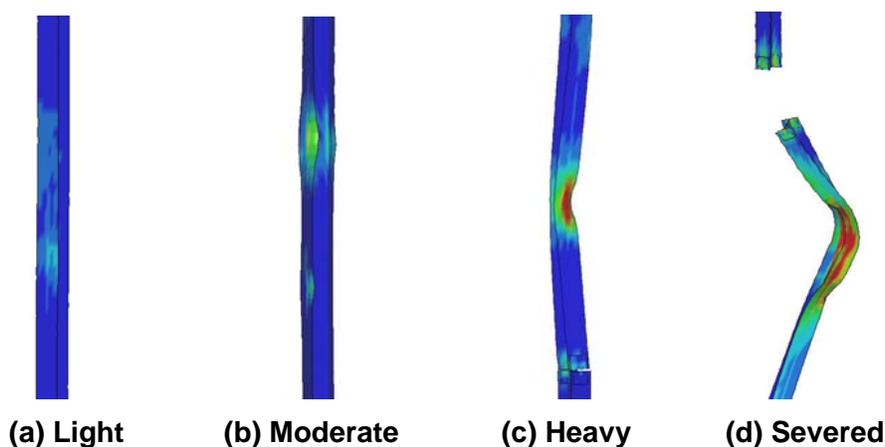
Figure 6–19. Column damage levels.

- Lightly damaged column: column impacted, but without significant structural deformation;
- Moderately damaged column: visible local distortion, but no deformation of the column centerline;
- Heavily damaged column: Permanent deflection of the column centerline; and
- Failed column: Column severed.

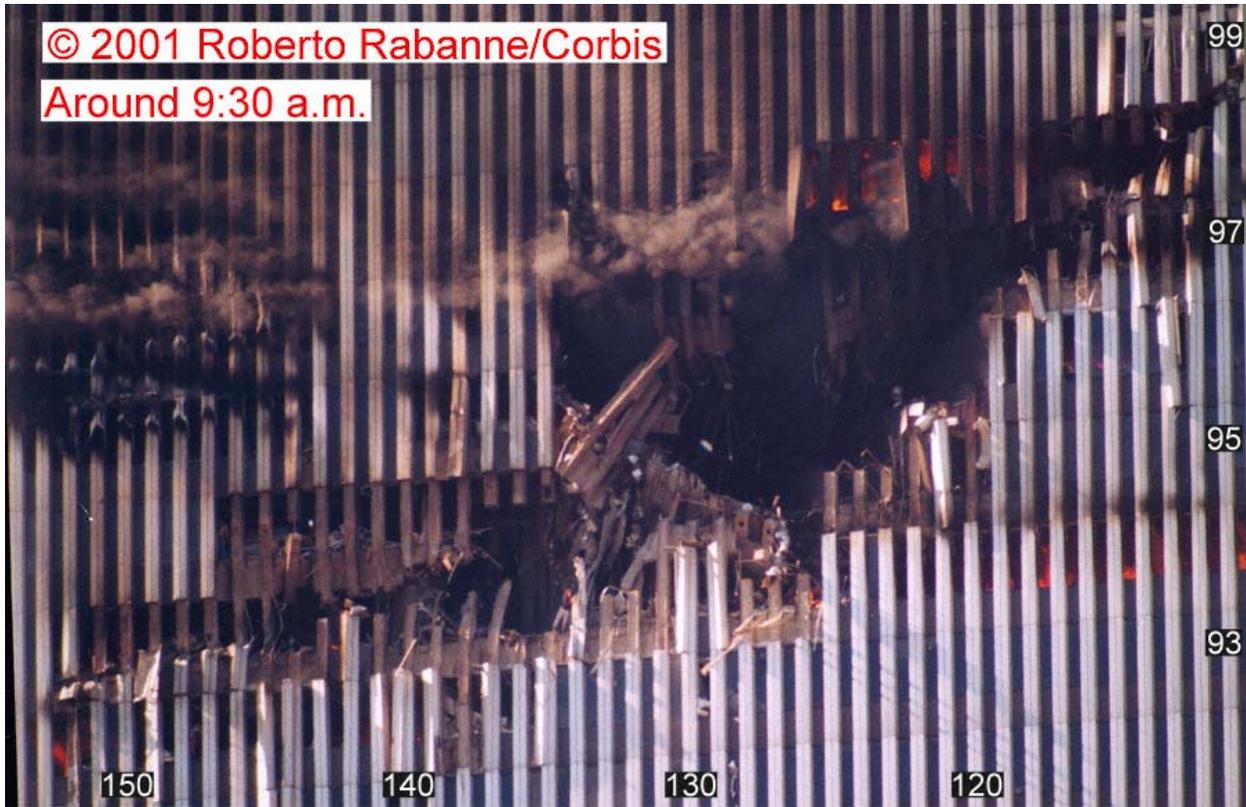
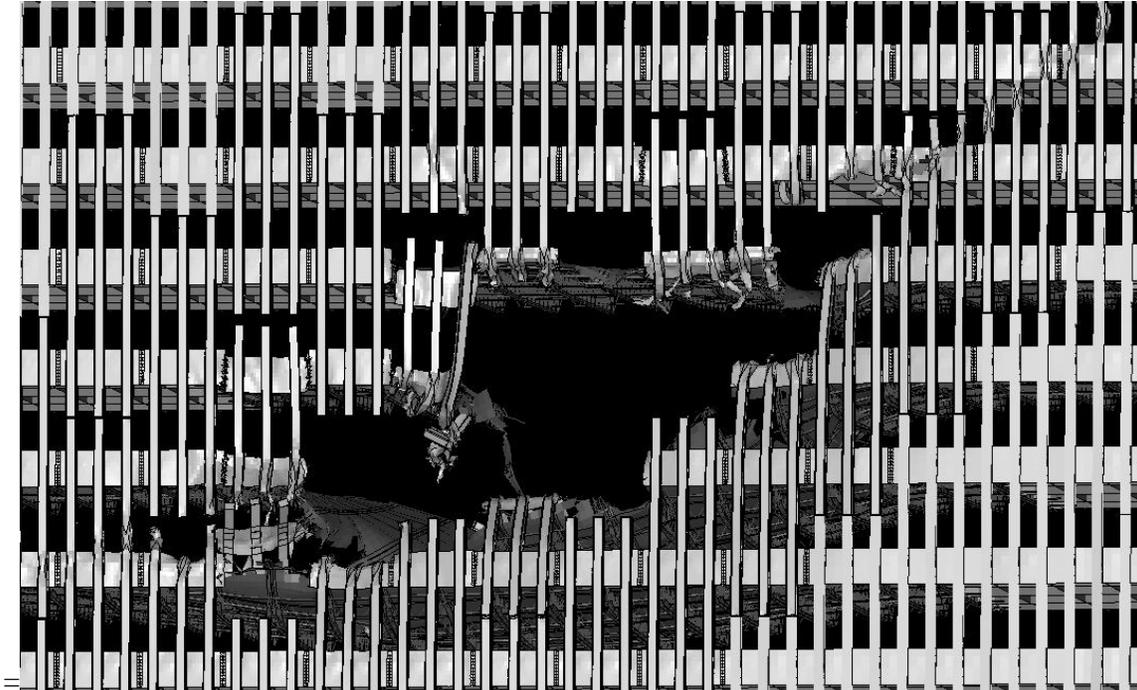
Figure 6–26. Observed and Case A calculated damage to the north face of WTC 1.

Assessment of the aircraft impact simulations of exterior damage to the towers involved comparing the predicted perimeter wall damage near the impact zone with post-impact photographs of the walls. Figure 6–26 shows a photograph of the north face of WTC 1 after impact and the results of the Case A simulation. The calculated silhouettes capture both the position and shape of the actual damage.

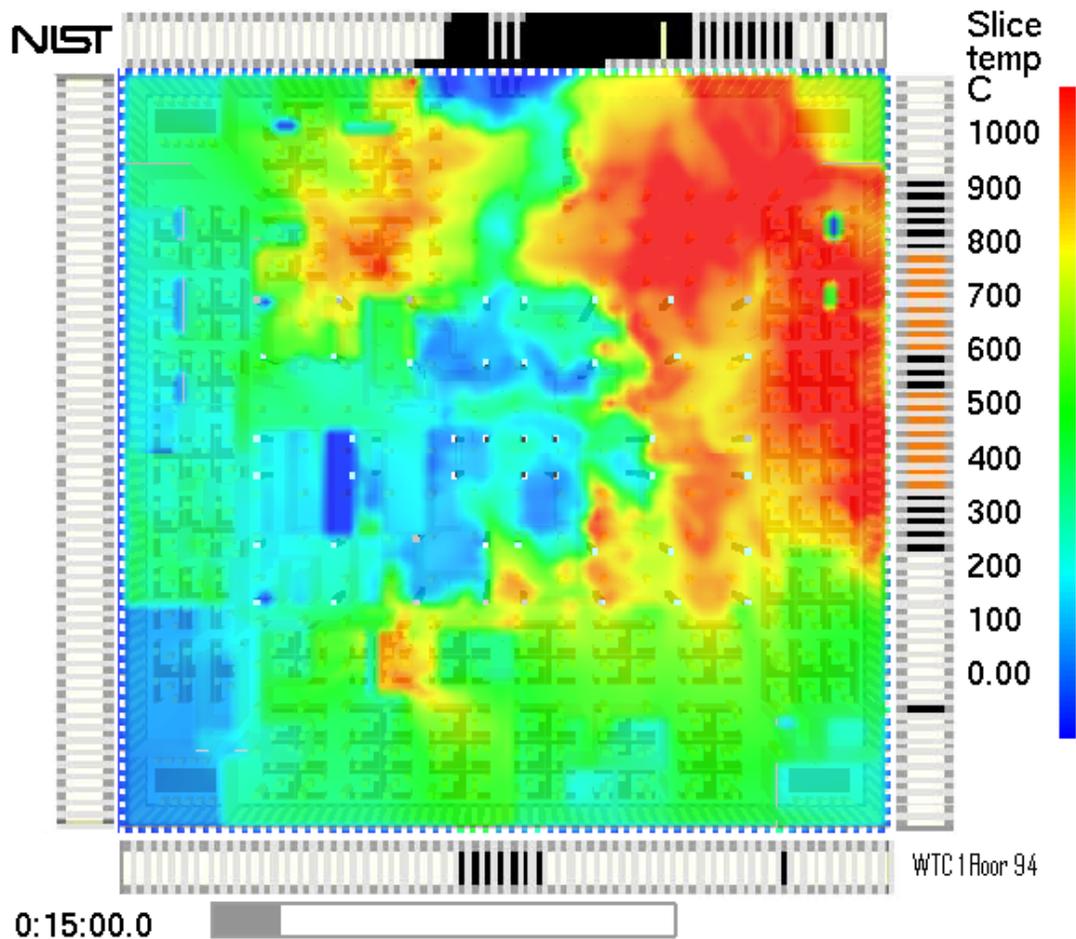
Figure 6–36. Upper layer temperatures on the 94th floor of WTC 1, 15 min after impact.

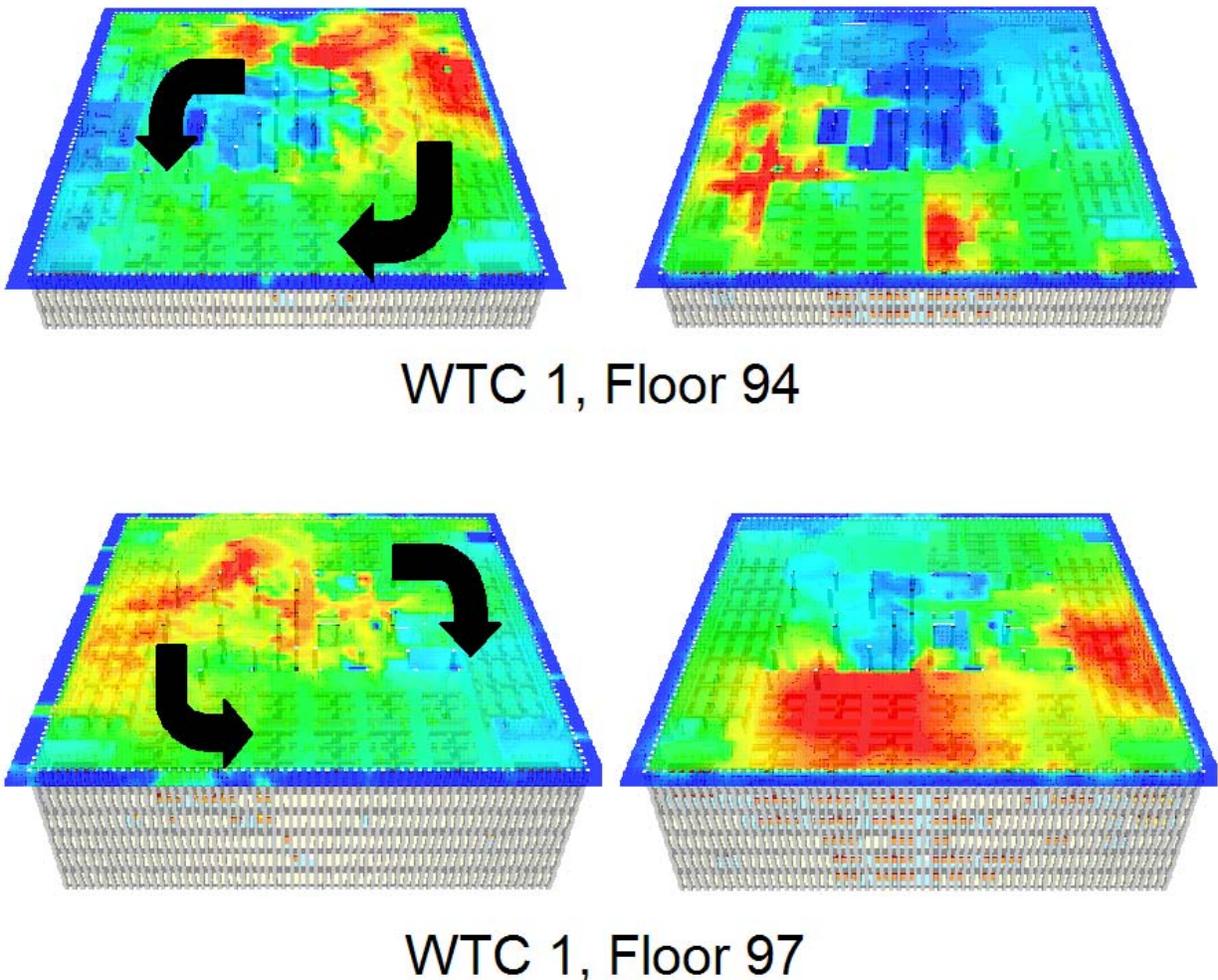
Much of the fire activity was initially in the vicinity of the impact area in the north part of the building. As a result of the orientation of the impacting aircraft and its fuel tanks, the early fires on the 92nd through 94th floors tended toward the east side of the north face, while the early fires on the 97th through 99th floors tended toward the west side of the north face. The fires on all the floors spread along the east and west sides and were concentrated in the south part of the building at the time of collapse, as depicted in Figure 6–37.

Figure 6–37. Direction of simulated fire movement on floors 94 and 97 of WTC 1.

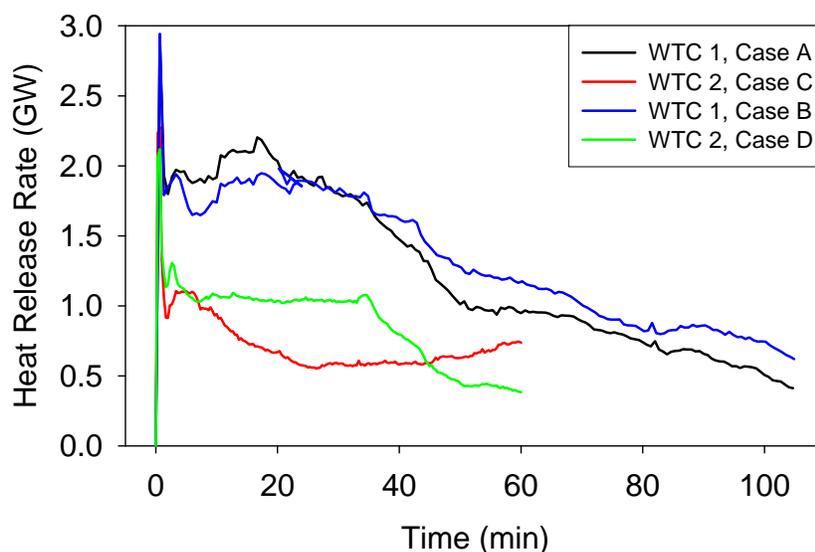
Much of the information needed to simulate the fires came from laboratory-scale tests. While some of these involved enclosures several meters in dimension and fires that reached heat release rates of 10 MW and 12 GJ in total heat output, they were still far smaller than the fires that burned in the WTC towers. Figure 6–38 shows the heat release rates from the FDS simulations of the WTC fires. The peak plateau heat release rates were about 2 GW for WTC 1 and 1 GW for WTC 2. Integrating the areas under these curves produced total heat outputs from the simulated fires of about 8,000 GJ from WTC 1 and 3,000 GJ from WTC 2.

Figure 6–38. Predicted heat release rates for fires in WTC 1 and WTC 2.

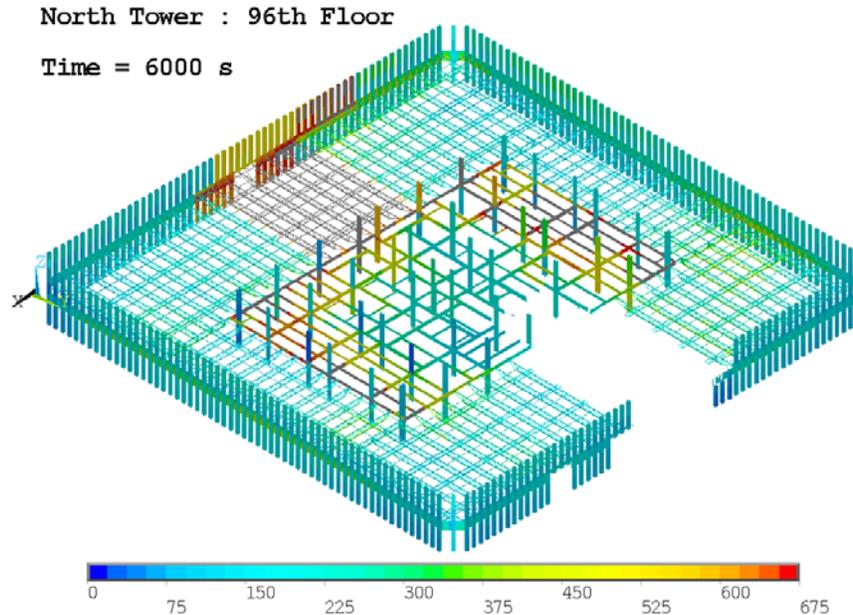
Figure 6–46. Temperatures (°C) on the columns and trusses of the 96th floor of WTC 1 at 6,000 s after aircraft impact, Case B.

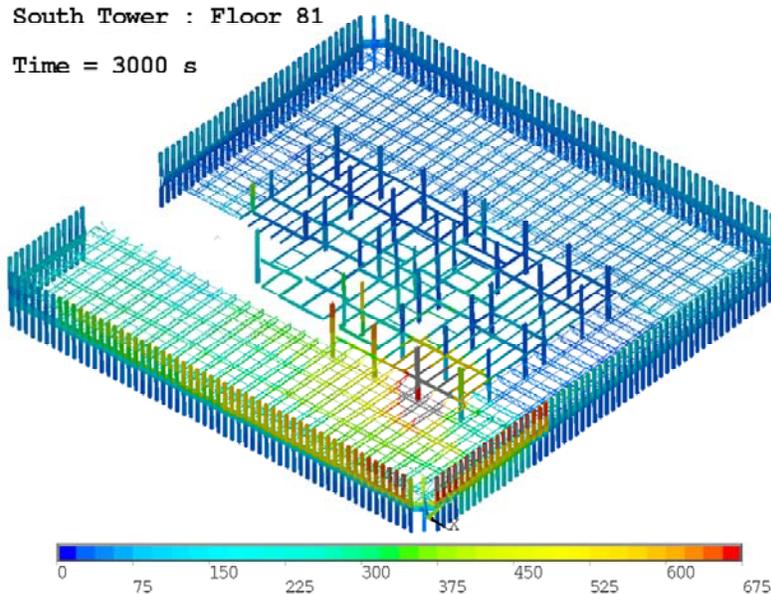
Figure 6–47. Temperatures (°C) on the columns and trusses of the 81st floor of WTC 2 at 3,000 s after aircraft impact, Case D.

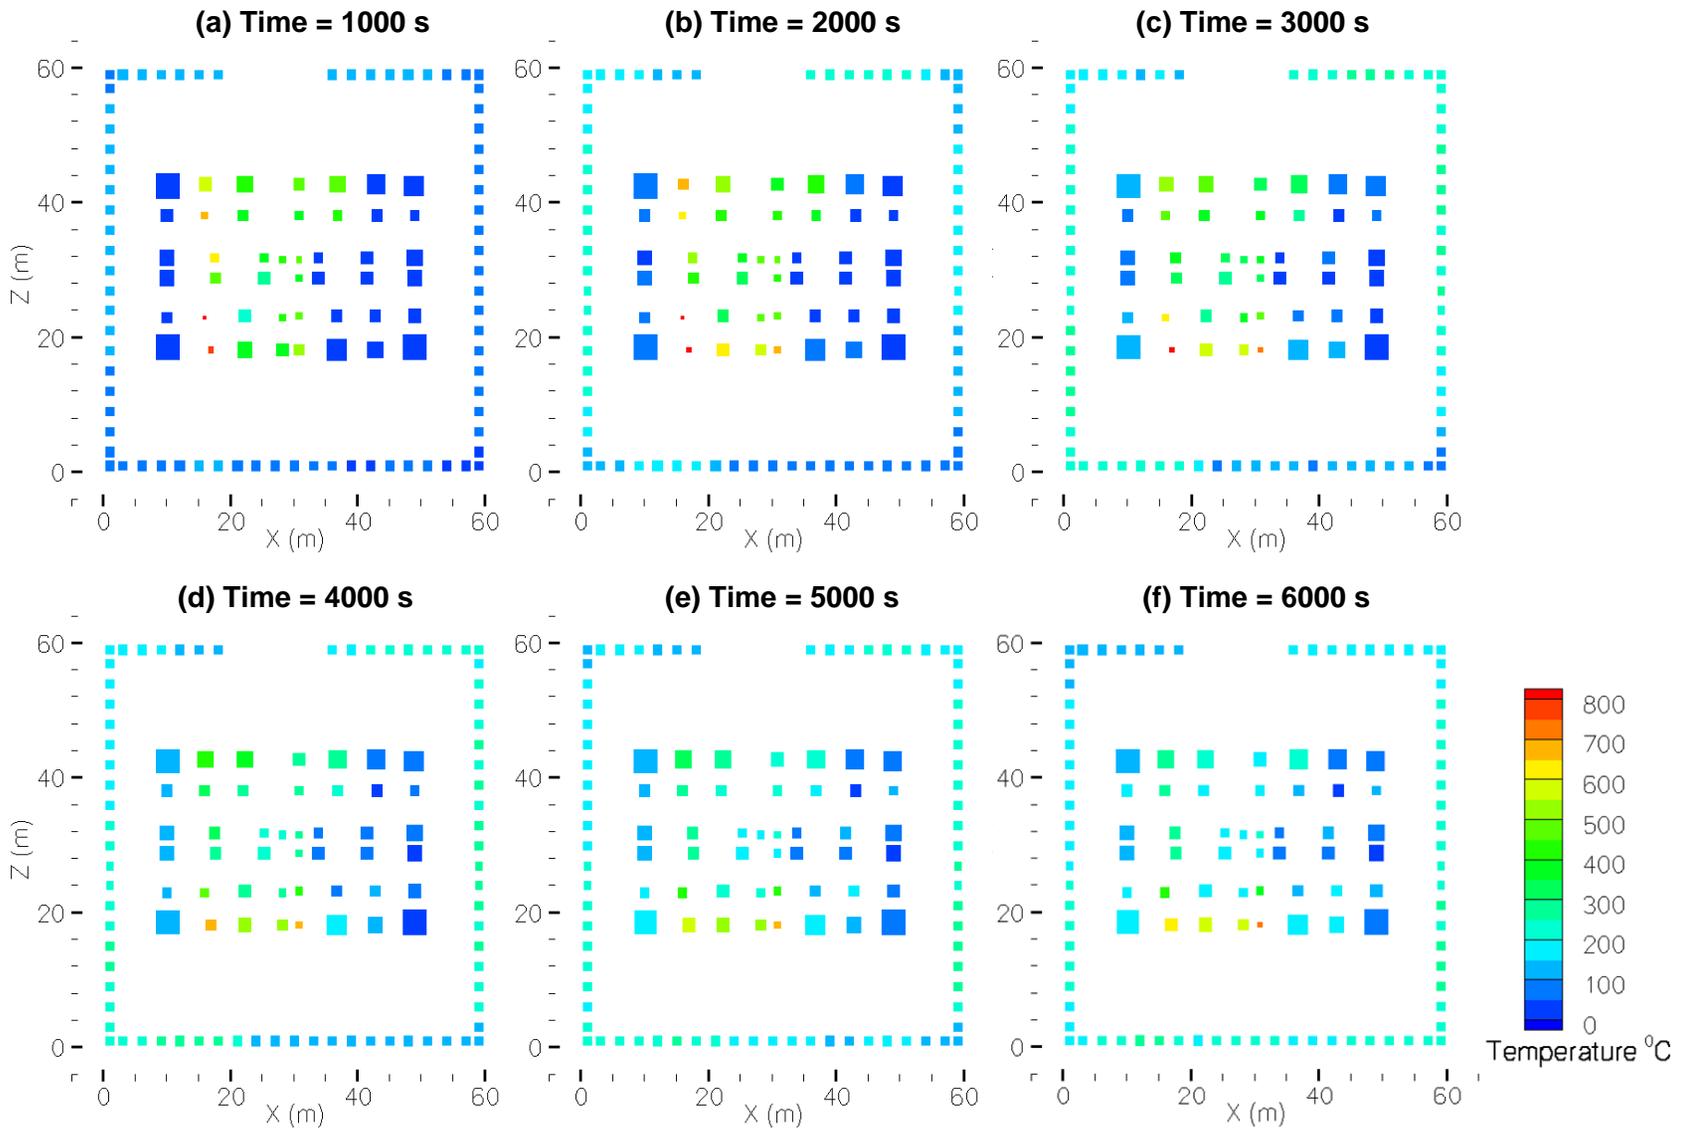
A third visualization tool was animation of the evolving temperatures of the columns. Frames from an example, again of the 96th floor of WTC 1, Case A, are shown in Figure 6–48. The size of the square representing a column represents its yield strength. Columns may have been heated when the fire was nearby and then cooled after the local combustibles were consumed.

Figure 6-48. Frames from animation of the thermal response of columns on the 96th floor of WTC 1, Case A.

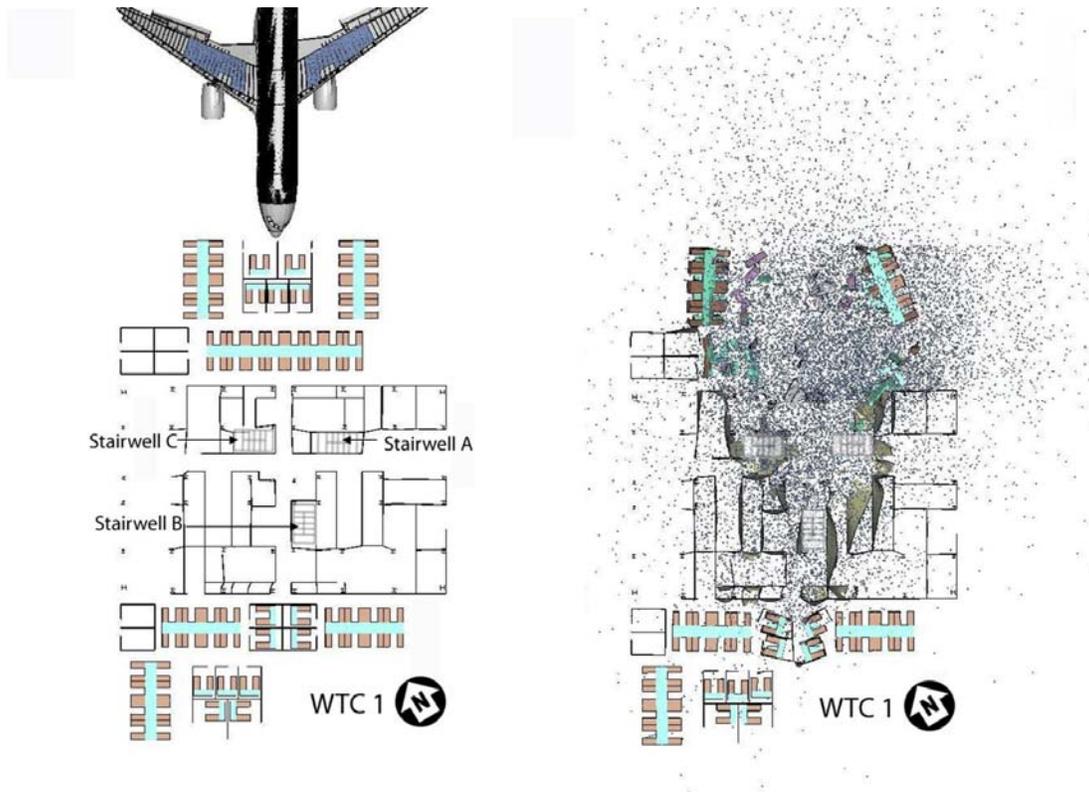
Figure 7-1. Simulated impact damage to 95th floor of WTC 1, including stairwells, 0.7 s after impact.

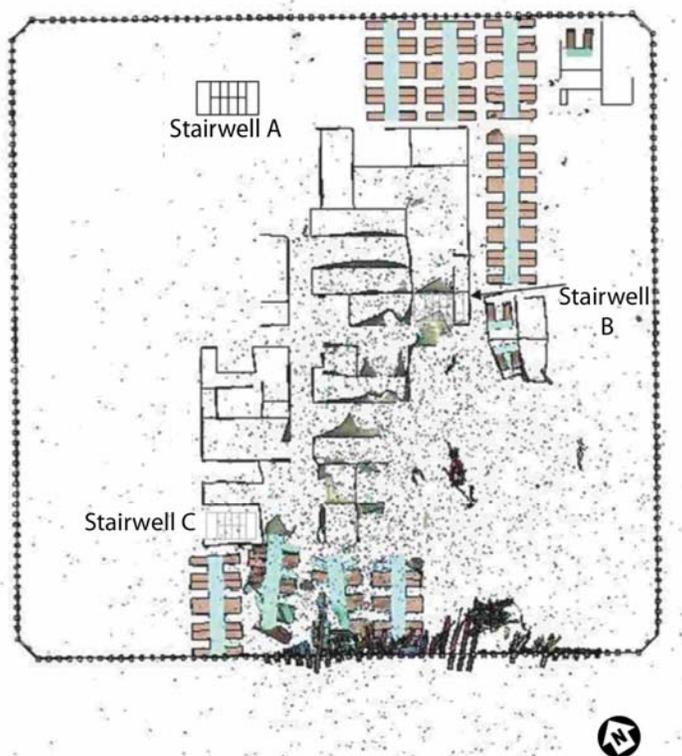
along different boundaries of the building core. United Airlines Flight 175 destroyed Stairwells B and C, but not Stairwell A (Figure 7-2).

Figure 7-2. Simulated impact damage to WTC 2 on floor 78, 0.62 s after impact.
